Harriet Tubman Middle School environmental background (prepared for Faubion K-8 move-in)

November 6, 2017

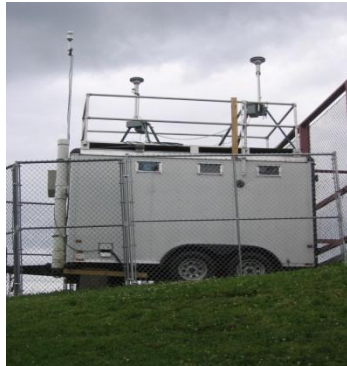
Air toxics monitor at Harriet Tubman

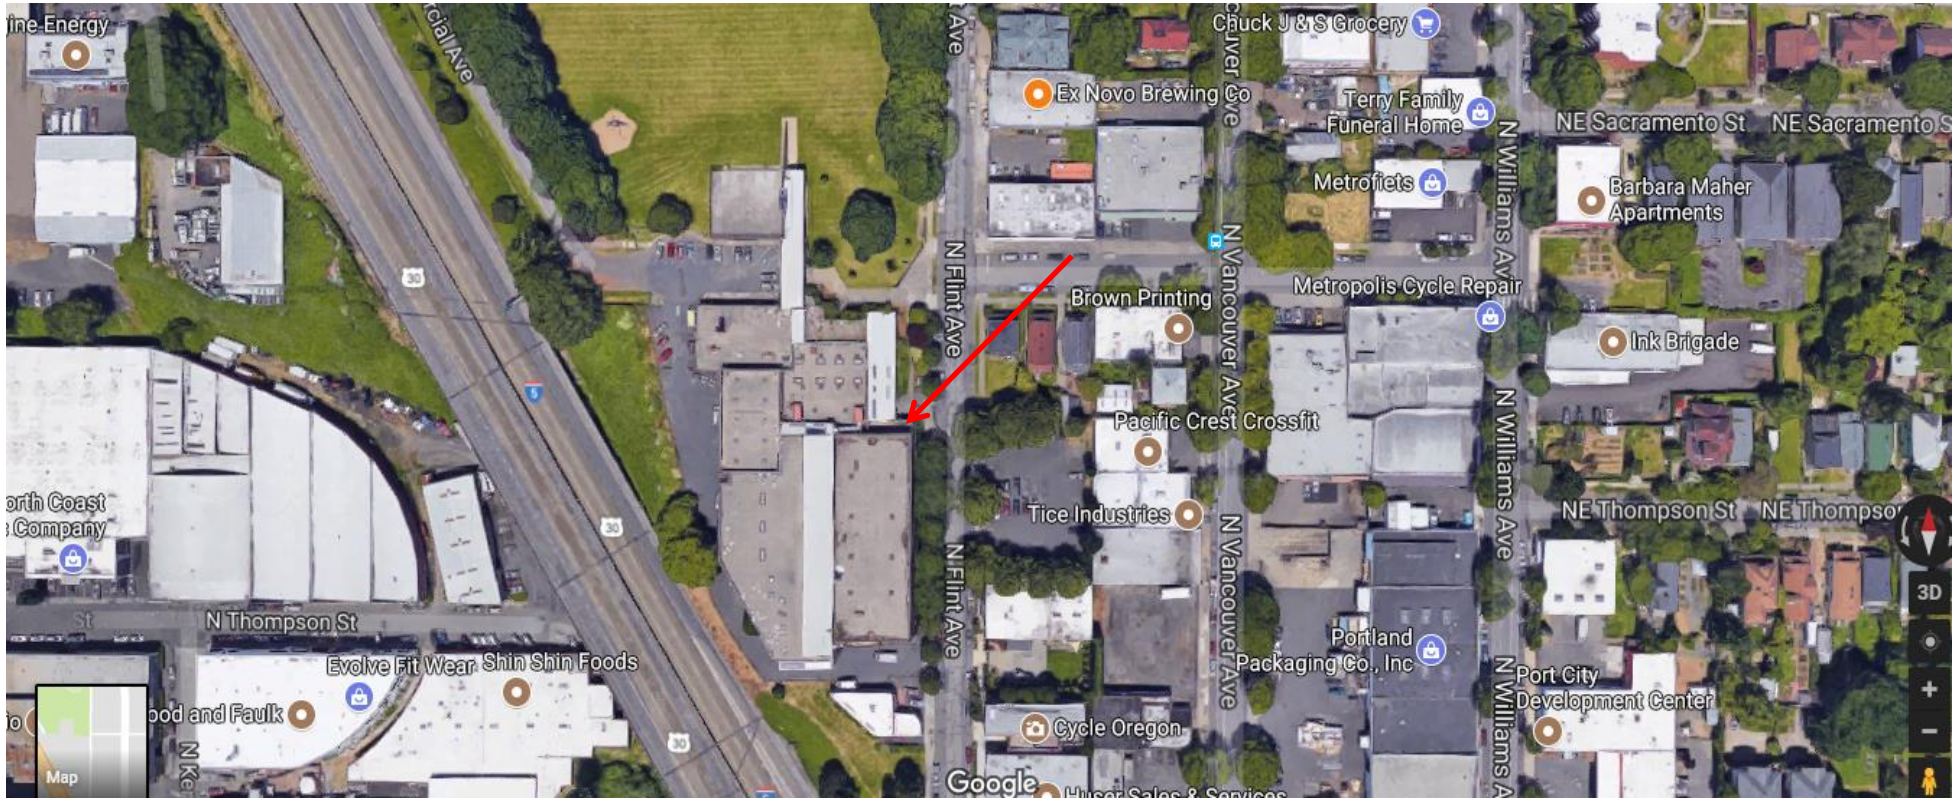
Arrow to most problematic roof section (water leaks) above offices.
