LONG-RANGE FACILITY PLAN

VOLUME 2: SITE SUMMARIES

PORTLAND PUBLIC SCHOOLS

2021 11 22 - BOE REVIEW DRAFT

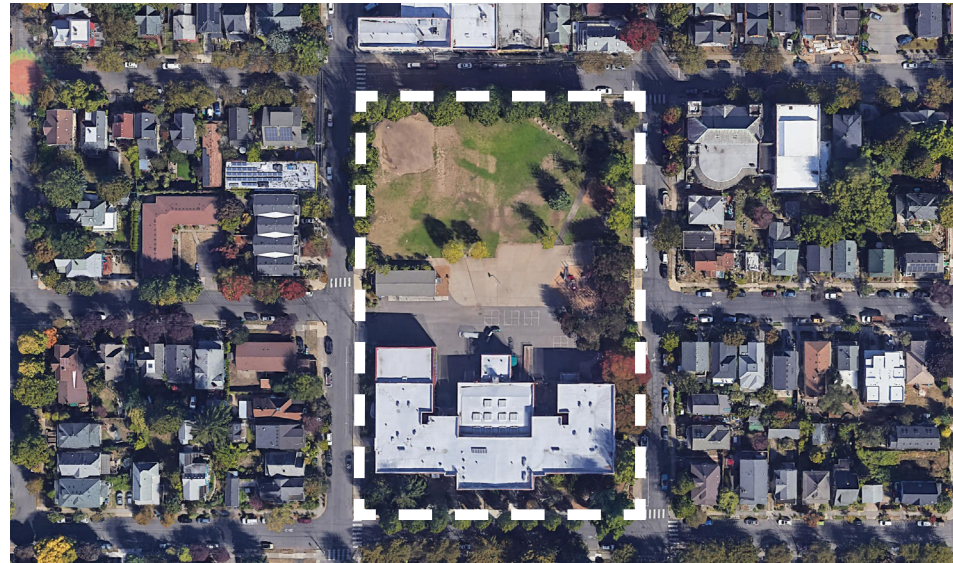
Sunnyside K-8 School is situated in the primarily single-family residential Sunnyside neighborhood of Southeast Portland. Built in 1925, the two-story school building with a ground floor basement has a reinforced concrete structure and is covered with brick veneer. The exterior is distinguished by its Classical Revival style cast stone and terra cotta ornamentation. The building's irregular shaped plan includes classrooms, an auditorium, a gymnasium, a cafeteria, a library, and an administrative office.

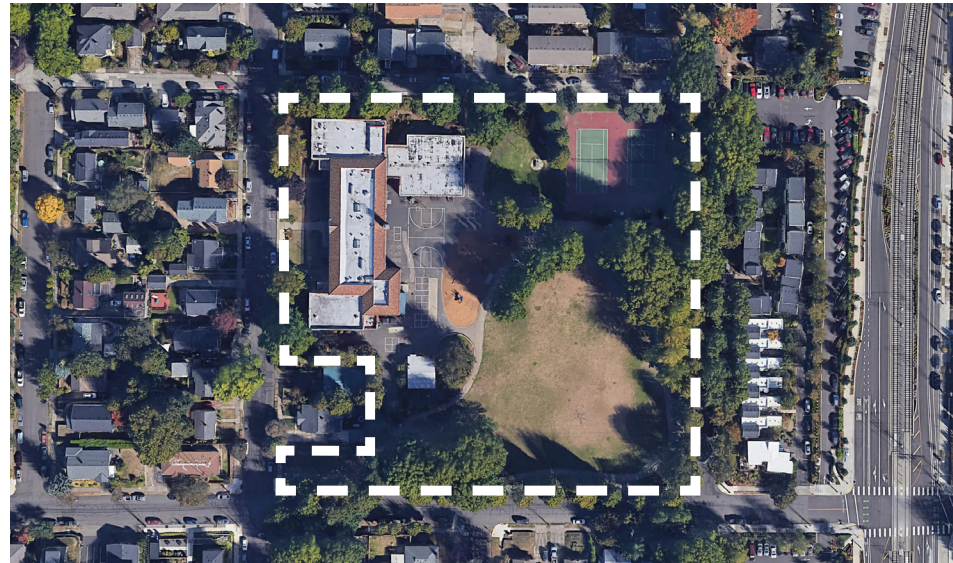
Winterhaven School (formerly Brooklyn), is located in the Brooklyn neighborhood of Southeast Portland. The campus includes the L-shaped school building and a detached portable classroom.

Faced with variegated brick, the reinforced concrete building rests on a poured concrete foundation. Two bays project slightly from the west elevation to create a slight enclosure for the entry. The entry door is flanked by engaged pilasters and exhibits a wood window with a cast stone surrounded with bottom scrolls. Designed in the Mediterranean-Revival style, cast stone architectural details are located throughout the building and include cast stone coping, water table, and scroll work above the primary entry door. A brick chimney projects above the east elevation. Fenestration consists primarily of six-over-six, wood frame windows.

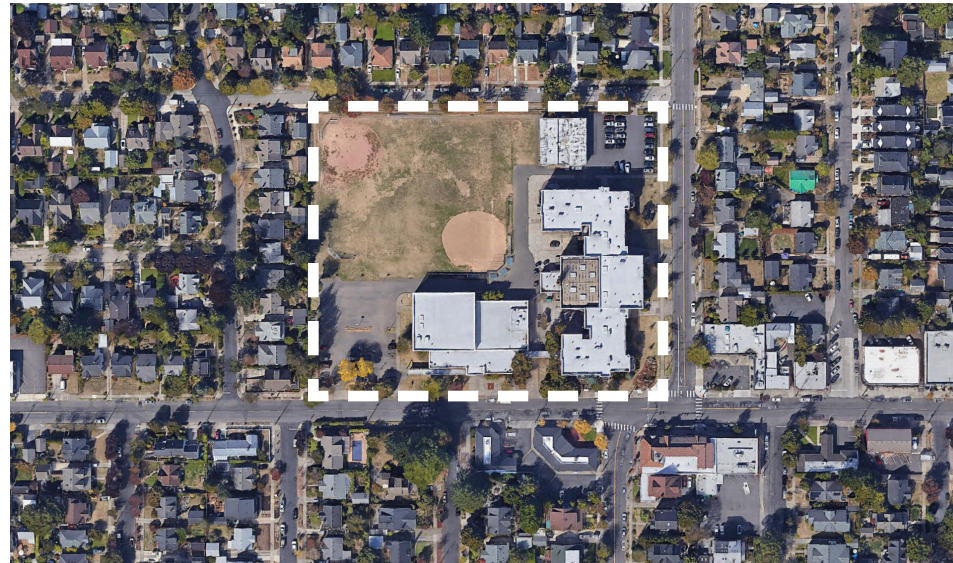
Situated in the Beaumont-Wilshire neighborhood of East Portland, the Beaumont Middle School campus consists of a 1926 U-shaped building with two detached additions that house classrooms and recreation space. The primary two-story Classical Revival building is constructed of concrete with brick veneer and ornamented by a cast-stone façade with shield motif. Double loaded corridors provide access to the administrative offices, classrooms, and recreation spaces.

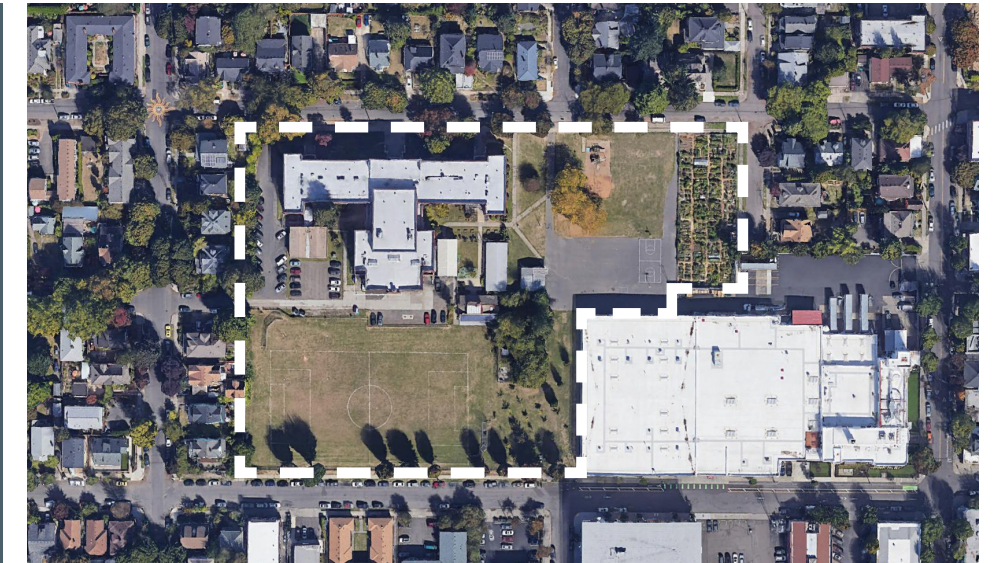
The Girl's Polytechnic High School (now known as da Vinci Arts Middle School) is a multi-story reinforced concrete structure with brick cladding designed in the Classical Revival style. The building is covered by a flat roof. The campus consists of a T-shaped building and four portable classroom buildings. Constructed in 1927, the school exhibits extensive use of cast-stone ornamentation to express its Classical Revival style.

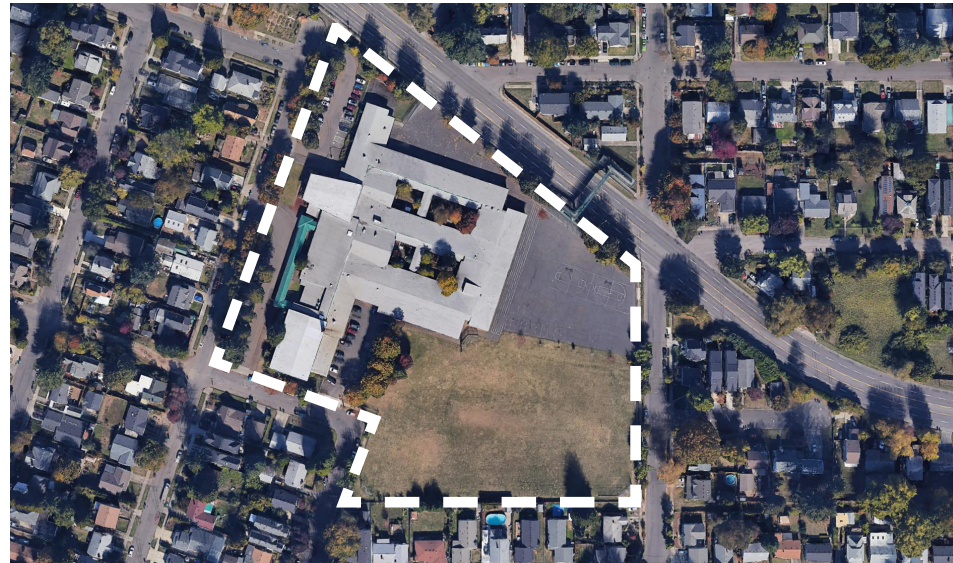
Built in 1950, the Northwest Regional style George Middle School building is situated on a grass and asphalt-covered campus. The single story wood frame building is clad with brick veneer. The irregular shape plan building provides facilities for classrooms, a gymnasium, an auditorium, a media center, a cafeteria and an administrative office. Situated in a primarily residential area adjacent to the St. Johns neighborhood of North Portland the George Middle School, which faces North Burr Avenue, is built in the style of many post-World War II schools, with projecting “fingers” and courtyard. The asphalt-covered playground and playfields are located directly east and southeast of the school. An asphalt-covered half-circular driveway provides access to the front (west) elevation and the parking area is situated on the northwest corner of the school property near the front entrance.
